Americans with Disabilities Act Transition Plan

Sonoma County Community Development Commission
Sonoma County Housing Authority
1440 Guerneville Road, Santa Rosa, CA 95403-4107

II. Survey Data - Facilities

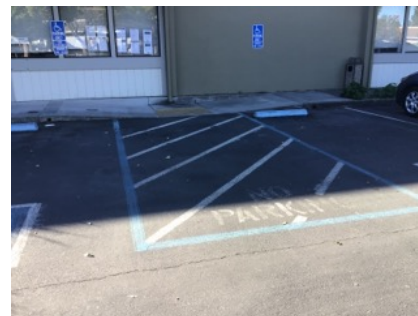
- 2
- *As-Built Description:*
Parking sign is not located between 60" and 80" above the finish floor or ground surface measured to the bottom of the sign.
 - *Original Description:*
Parking signage is too low at 43" to bottom of sign from finished floor.
 - *As-Built:* **43" high at bottom of sign**
 - *Proposed Solution:*
Remount existing sign at accessible height.

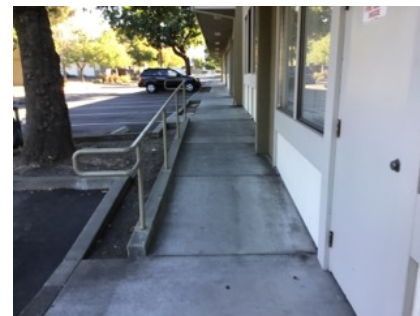
Cross Slope

- 5
- **As-Built Description:**
Cross slope more than 1":48" (2.083%).
 - **As-Built:** **2.4% cross slope**
 - **Proposed Solution:**
Modify cross slope.

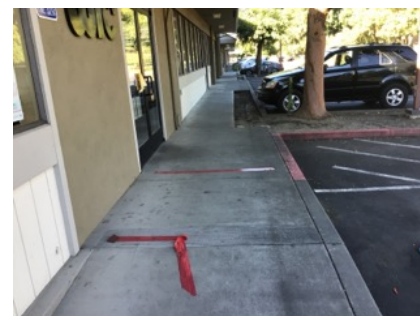
General Note

- 6
- **As-Built Description:**
Refer to notes for observation and recommendation.
 - **Notes:**
Must travel through parking lot to get to sidewalk.

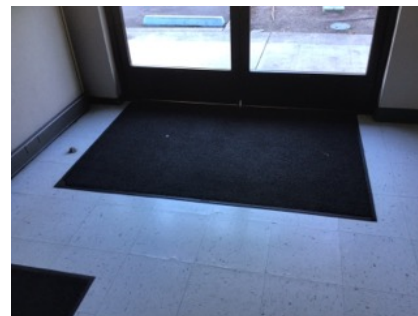
105	<ul style="list-style-type: none"> • <i>As-Built Description:</i> Doormat hinders access to disabled persons. • <i>Proposed Solution:</i> Provide new doormat; recess or attach at edges. 	ADAAG 91 4.5.3

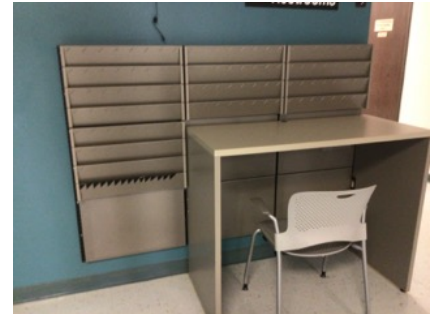
Reach Range

- 13 • *As-Built Description:*
Reach height for front approach to control or access point over an obstruction with 27" min. knee clearance and 25" max. deep exceeds 44".
- *Original Description:*
Pamphlet display area above counter, which is 20 -3/4" deep, is out of reach range. All pamphlet access in this area is above 44".
- *As-Built:* **Greater than 44" high over 20.75" deep to pamphlets**
- *Proposed Solution:*
Modify equipment or mounting.

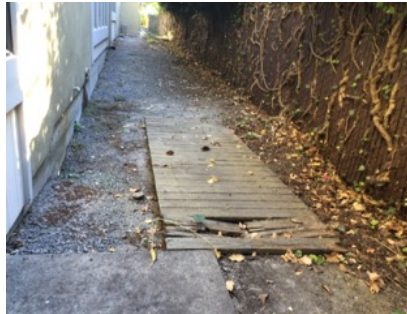
Door Clearance

<p>17</p> <ul style="list-style-type: none"> <i>As-Built Description:</i> Door on accessible route has less than 32" clear and 80" (78" min. to closer if provided) opening width when 90° open. <i>Original Description:</i> Door width is 30" <i>As-Built:</i> 30" wide <i>Proposed Solution:</i> Provide new, larger door and frame with new accessible hardware. 	<p>ADAAG 91 4.13.5 ADA 2010 404.2.3 CBC 2007 1133B.1.1.1.1 CBC 2019 11B-404.2.3</p>	<p>1 JOB \$7,800 \$7,800</p>

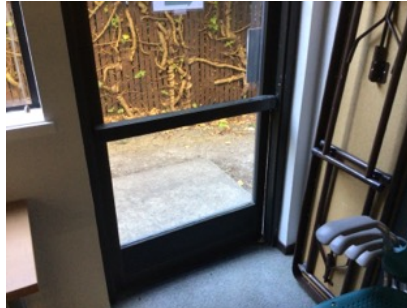
Door Closer

<p>18</p> <ul style="list-style-type: none"> <i>As-Built Description:</i> Excessive force required to open door. <i>Original Description:</i> Door pressure is 15 lbs. <i>As-Built:</i> 15 lbs <i>Proposed Solution:</i> Adjust regular door closer to accessible standards (5 lbs. max). 	<p>ADAAG 91 4.13.11 ADA 2010 404.2.9 CBC 2007 1133B.2.5 CBC 2019 11B-404.2.9</p>	<p>1 JOB \$75 \$75</p>

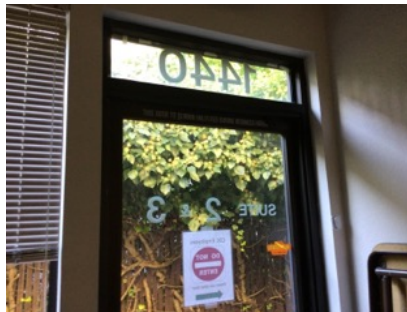
Item no., Rm no. and Name	Existing Architectural Barrier and Proposed Solution	Codes / Mitigation Info	Qty	Unit	Cost	Total
Door Swing						
19	<ul style="list-style-type: none"> As-Built Description: Front approach: At pull side, door does not have clear and level maneuvering space measuring door width plus 18" x 60". (24" x 60" at exterior doors). Original Description: Pull side landing does not have 24" clearance beyond the latch (concrete ends prior to 24"). As-Built: Door width plus <24" to dirt Proposed Solution: Increase size on concrete landing. 	ADAAG 91 Fig. 25(a) ADA 2010 404.2.4 CBC 2007 11B-26A(a) CBC 2019 11B-404.2.4	1	JOB	\$150	\$150
		Mitigated: <input type="radio"/> YES <input checked="" type="radio"/> NO Priority 2 Severity 2

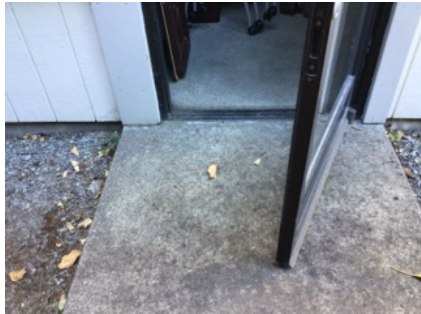
20	<ul style="list-style-type: none"> As-Built Description: Front approach: At pull side, door does not have clear and level maneuvering space measuring door width plus 18" x 60". (24" x 60" at exterior doors). Original Description: Landing on the pull side has only 48" perpendicular to the door. As-Built: 48" from face of door to dirt Proposed Solution: Increase landing. 	ADAAG 91 Fig. 25(a) ADA 2010 404.2.4 CBC 2007 11B-26A(a) CBC 2019 11B-404.2.4	1	JOB	\$150	\$150

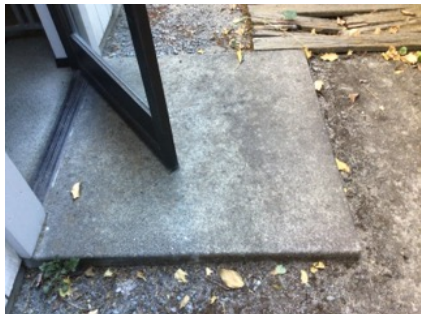
Door Swing						
21	<ul style="list-style-type: none"> As-Built Description: Front approach: At push side, door does not have clear and level maneuvering space measuring door width x 48" (door width plus 12" if door has both, latch and closer). Original Description: No clear floor space in front of door. Proposed Solution: Remove or relocate furniture or storage items. 	ADAAG 91 Fig. 25(a) ADA 2010 404.2.4 CBC 2007 11B-26A(a) CBC 2019 11B-404.2.4	1	JOB	\$150	\$150
		Mitigated: <input type="radio"/> YES <input checked="" type="radio"/> NO Priority 2 Severity 2

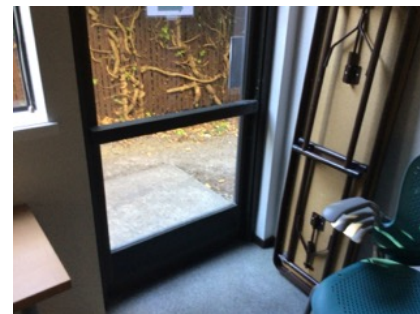
Signage

23 • *As-Built Description:*
 At final exit door to exterior: Where required exit signs are installed, signs to provide exiting information for people with vision impairment are not provided.
 • *Original Description:*
No signage (door is shown as emergency exit door on evacuation plan).
 • *Proposed Solution:*
 Provide raised letter/Braille "EXIT" sign at door.
 • **Notes:**
Optional solution is to provided signage that this is not an exit and direct neone to other exit door.

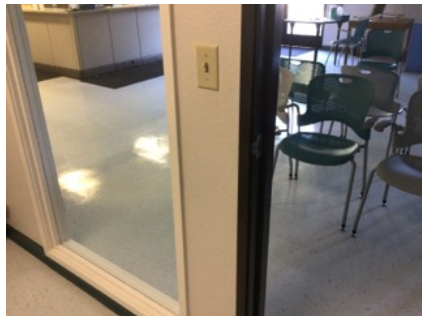
28	<ul style="list-style-type: none"> <i>As-Built Description:</i> Electric switch or control mounted less than 15" measured to the bottom of the outlet box or greater than 48 inches measured to the top of the outlet box. <i>Original Description:</i> Light switches in all Interview Rooms (a,b,c,d) are out of reach range. Top of outlet box is at 49" above finished floor. <i>As-Built:</i> 49" high to top of box <i>Proposed Solution:</i> Relocate light switches or control to between 15" and 48" height. 	ADAAG 91 4.2.5 & 6 ADA 2010 308.2.1 & CBC 2007 1117B.6.3 CBC 2019 11B-308.2.1 & 11B-308.2.2	1	JOB	\$900	\$900
		Mitigated: <input type="radio"/> YES <input checked="" type="radio"/> NO Priority 2 Severity 4

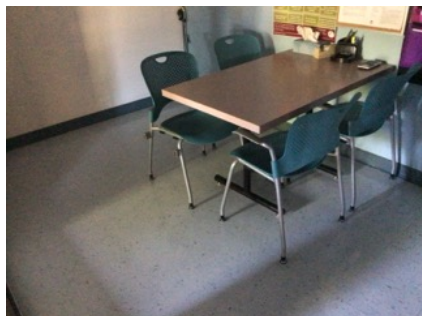
Turning Space

29	<ul style="list-style-type: none"> <i>As-Built Description:</i> The area does not provide a minimum 60" diameter turning space within to allow maneuvering through the space. <i>Original Description:</i> Interview rooms A & B do not provide room for 60" diameter turning radius at table. <i>Proposed Solution:</i> Modify area to provide sufficient maneuvering space. 	ADA 2010 304.3 CBC 2019 11B-304.3	1	JOB	\$1,500	\$1,500
		Mitigated: <input type="radio"/> YES <input checked="" type="radio"/> NO Priority 2 Severity 3

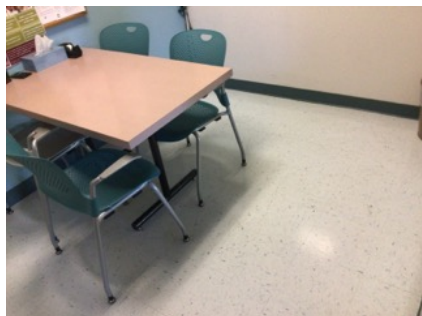
30	<ul style="list-style-type: none"> <i>As-Built Description:</i> The area does not provide a minimum 60" diameter turning space within to allow maneuvering through the space. <i>Original Description:</i> Interview room D does not provide room for 60" diameter turning radius at table. <i>Proposed Solution:</i> Modify area to provide sufficient maneuvering space. 	ADA 2010 304.3 CBC 2019 11B-304.3	1	JOB	\$1,500	\$1,500
		Mitigated: <input type="radio"/> YES <input checked="" type="radio"/> NO Priority 2 Severity 3

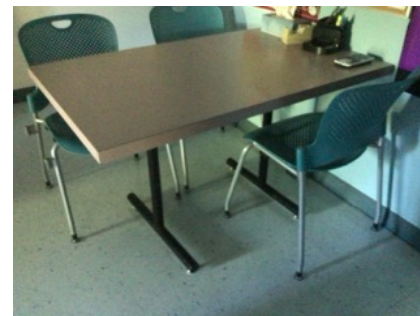
Signage

- 32 • *As-Built Description:*
Existing sign designating permanent room or space is noncompliant.
- *Original Description:*
Interview rooms A, B, C & D do not have room identification signage.
- *Proposed Solution:*
Provide compliant signage.

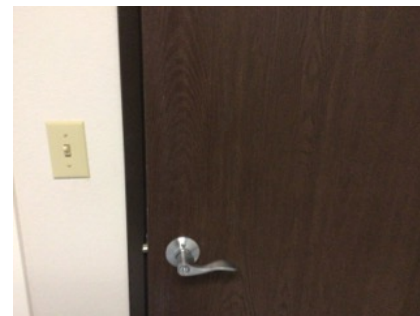
Signage

- 34
- *As-Built Description:*
Existing sign designating permanent room or space is noncompliant.
 - *Original Description:*
Family Self Sufficiency Resource Room does not have proper room identification signage.
 - *Proposed Solution:*
Provide compliant signage.

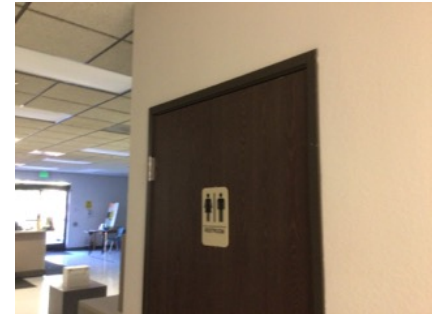
35	<ul style="list-style-type: none"> • <i>As-Built Description:</i> Excessive force required to open door. • <i>As-Built:</i> 7 lbs • <i>Proposed Solution:</i> Adjust regular door closer to accessible standards (5 lbs. max). 	ADAAG 91 4.13.11	1	JOB	\$75	\$75
		ADA 2010 404.2.9				
		CBC 2007 1133B.2.5				
		CBC 2019 11B-404.2.9				
Mitigated: <input type="radio"/> YES <input checked="" type="radio"/> NO		Priority 2 Severity 4

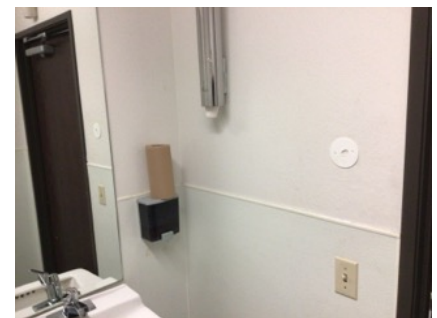
Reach Range

36	<ul style="list-style-type: none"> • <i>As-Built Description:</i> Reach height to control or access point, exceeds 48" or is less than 15". • <i>Original Description:</i> Cup dispenser mounted with bottom at 62" above finished floor. • <i>As-Built:</i> 62" high • <i>Proposed Solution:</i> Modify equipment or mounting. 	ADAAG 91 4.2.5	1	JOB	\$300	\$300
		ADA 2010 308.2.1				
		CBC 2007 1118B.5				
		CBC 2019 11B-308.2.1				
Mitigated: <input type="radio"/> YES <input checked="" type="radio"/> NO		Priority 2 Severity 2

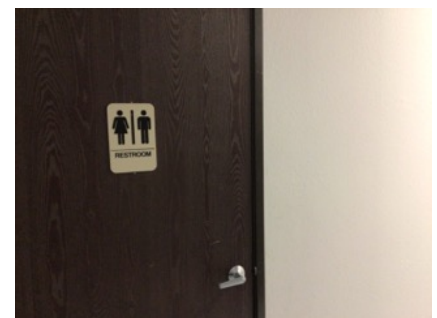
Signage

37	<ul style="list-style-type: none"> • <i>As-Built Description:</i> Entrance to toilet or bathing facility not identified with ADAAG compliant signage. • <i>Original Description:</i> Incorrect signage installed. • <i>Proposed Solution:</i> Provide ADA compliant sign mounted at 48" min. above to baseline of the lowest Braille cells and 60" max. to baseline of the highest line of raised characters on nearest adjacent wall, on latch side of a single door (located not to cause a Braille reader to stand within the door swing). 	ADAAG 91 4.1.3(16)(a)	1	JOB	\$270	\$270
		ADA 2010 216.8				
		CBC 2019 11B-216.8				
		Mitigated: <input type="radio"/> YES <input checked="" type="radio"/> NO

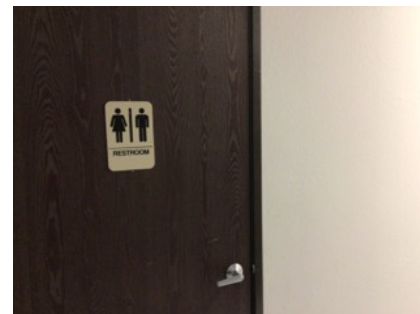
Toilet Stall

- 39 • *As-Built Description:*
60" min. clearance around a water closet measured perpendicular from the side wall not provided (Fixtures are not allowed to overlap this clearance).
- *As-Built:* **50" wide from wall to lavatory**
- *Proposed Solution:*
Remove adjacent fixture and provide new enclosure at accessible water closet.

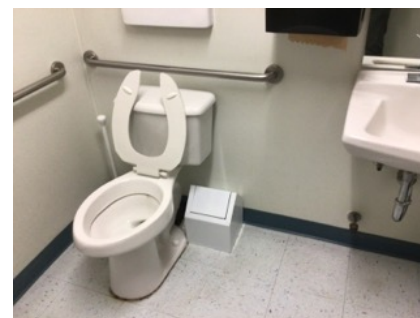
Water Closet

- 40 • *As-Built Description:*
CA only: In single-accommodation restroom less than 48" in front of water closet provided.
- *Original Description:*
Table in front of water closet does not allow required 48" clearance in front.
- *As-Built:* **Less than 48" in front of WC**
- *Proposed Solution:*
Remove table.

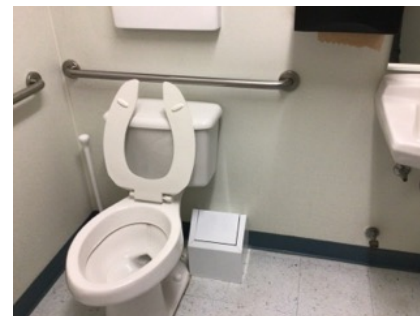
Water Closet

- 42 • *As-Built Description:*
Flush Control: Operating handle not mounted toward wide side of stall.
- *Original Description:*
Flush control is located on wall side of water closet.
- *Proposed Solution:*
Replace flush control with properly mounted accessible type, or install sensor flush.

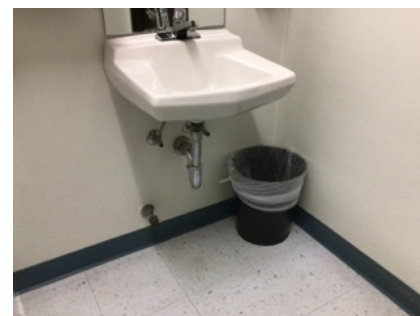
Item no., Rm no. and Name	Existing Architectural Barrier and Proposed Solution	Codes / Mitigation Info	Qty	Unit	Cost	Total
Accessories						
44	<ul style="list-style-type: none"> <i>As-Built Description:</i> Dispensers in sanitary facilities, such as for towels, soap, sanitary napkins, seat covers, etc., and waste receptacles more than 48" (CA only: 40") from floor to highest operating slot or control. <i>Original Description:</i> Soap dispenser operable part mounted at 41" above finished floor. <i>As-Built:</i> SD: 41" high <i>Proposed Solution:</i> Relocate existing restroom accessories. 	ADAAG 91 4.23.7 ADA 2010 308.2.1 CBC 2007 1115B.8.3 CBC 2019 11B-603.5	1	JOB	\$300	\$300
		Mitigated: <input type="radio"/> YES <input checked="" type="radio"/> NO Priority 2 Severity 4

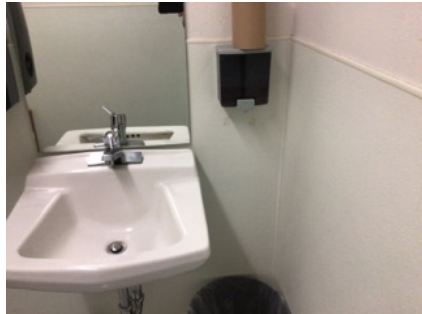
45	<ul style="list-style-type: none"> <i>As-Built Description:</i> Dispensers in sanitary facilities, such as for towels, soap, sanitary napkins, seat covers, etc., and waste receptacles more than 48" (CA only: 40") from floor to highest operating slot or control. <i>Original Description:</i> Paper towel dispenser operable part mounted at 45" above finished floor. <i>As-Built:</i> PTD: 45" high <i>Proposed Solution:</i> Relocate existing restroom accessories. 	ADAAG 91 4.23.7 ADA 2010 308.2.1 CBC 2007 1115B.8.3 CBC 2019 11B-603.5	1	JOB	\$300	\$300

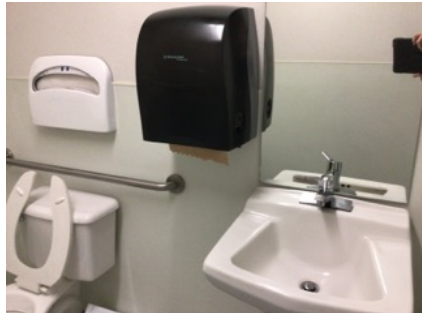
46	<ul style="list-style-type: none"> <i>As-Built Description:</i> Dispensers in sanitary facilities, such as for towels, soap, sanitary napkins, seat covers, etc., and waste receptacles more than 48" (CA only: 40") from floor to highest operating slot or control. <i>Original Description:</i> Seat cover dispenser located at 48" above finished floor. <i>As-Built:</i> SCD: 48" high <i>Proposed Solution:</i> Relocate existing restroom accessories. 	ADAAG 91 4.23.7 ADA 2010 308.2.1 CBC 2007 1115B.8.3 CBC 2019 11B-603.5	1	JOB	\$300	\$300
		Mitigated: <input type="radio"/> YES <input checked="" type="radio"/> NO Priority 2 Severity 2

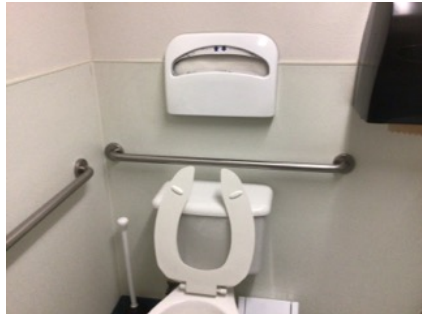
Item no., Rm no. and Name	Existing Architectural Barrier and Proposed Solution	Codes / Mitigation Info	Qty	Unit	Cost	Total
Coat Hook						
47	<ul style="list-style-type: none"> • <i>As-Built Description:</i> Accessible coat hook not within reach range. • <i>As-Built:</i> 66" high • <i>Proposed Solution:</i> Adjust existing or provide new coat hook at maximum 48" height. 	ADAAG 91 4.2.5 ADA 2010 603.4 CBC 2007 1118B.5 CBC 2019 11B-603.4	1	JOB	\$150	\$150
		Mitigated: <input type="radio"/> YES <input checked="" type="radio"/> NO			Priority 2 Severity 1

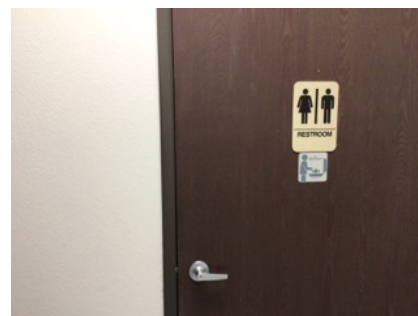
- 51 • *As-Built Description:*
Required in CA only: identification symbol centered 58" to 60" high on sanitary facility door that contrasts with the door not provided (women: 12" ø circle, men: 12" triangle, unisex: combined symbol).
- *Proposed Solution:*
Provide properly mounted sanitary facility symbol when altering area. If wheelchair accessible, include International Symbol of Accessibility on sign.

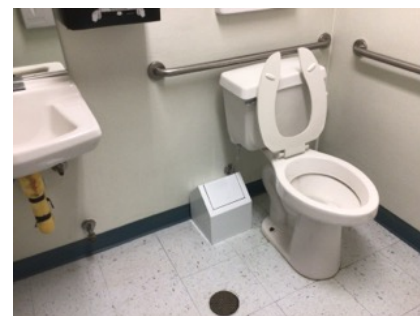
Water Closet

- 53 • *As-Built Description:*
Water closet not 16"-18" (CA: 17"-18") from near side wall to center line of water closet (2010 ADAAG: 16"-18").
- *Original Description:*
Centerline of water closet is 19" from side wall.
- *As-Built:* **19" o.c.**
- *Proposed Solution:*
Relocate existing water closet and plumbing, remount with offset closet flange to provide 18" max. from side wall.

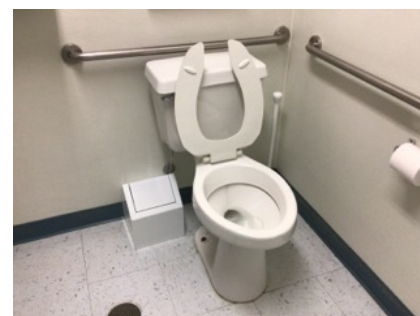
- 54 • *As-Built Description:*
CA only: In single-accommodation restroom less than 48" in front of water closet provided.
- *Original Description:*
Water closet only has 46" clearance in front.
- *As-Built:* **46" in front of WC**
- *Proposed Solution:*
Remodel restroom to provide at least 48" in front of water closet.

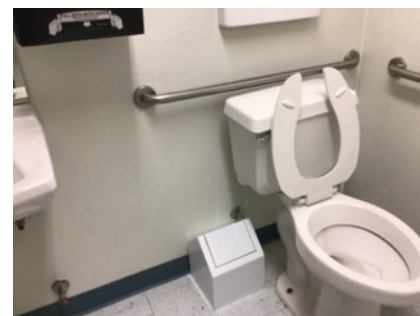
Accessories

- 56 • *As-Built Description:*
Dispensers in sanitary facilities, such as for towels, soap, sanitary napkins, seat covers, etc., and waste receptacles more than 48" (CA only: 40") from floor to highest operating slot or control.
- *Original Description:*
Paper towel dispenser operable part mounted at 45" above finished floor.
- *As-Built:* **PTD: 45" high**
- *Proposed Solution:*
Relocate existing restroom accessories.

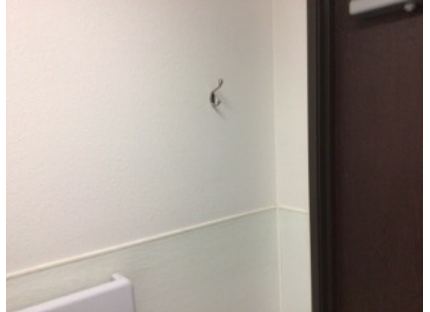
Item no., Rm no. and Name	Existing Architectural Barrier and Proposed Solution	Codes / Mitigation Info	Qty	Unit	Cost	Total
Coat Hook						
60	<ul style="list-style-type: none"> As-Built Description: Accessible coat hook not within reach range. Original Description: <i>Coat hook is mounted at 65-3/4" above finished floor.</i> As-Built: 65.75" high Proposed Solution: Adjust existing or provide new coat hook at maximum 48" height. 	ADAAG 91 4.2.5 ADA 2010 603.4 CBC 2007 1118B.5 CBC 2019 11B-603.4	1	JOB	\$150	\$150
		Mitigated: <input type="radio"/> YES <input checked="" type="radio"/> NO			Priority 2 Severity 2

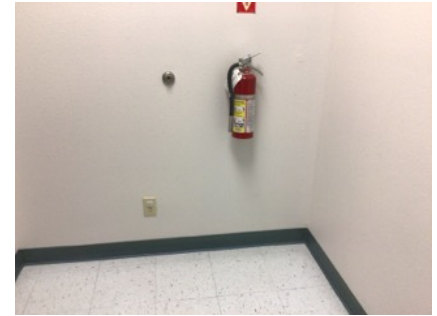
- 61 • *As-Built Description:*
Protruding objects more than 4" from wall, when bottom of object more than 27" or less than 80" above finished floor.
- *Original Description:*
Fire extinguisher protrudes 4-3/4" from wall with bottom at 29" above finished floor.
- *As-Built:* **Protrudes 4.75" at 29" high**
- *Proposed Solution:*
Provide cane-detectable railing to mark area of low clearance.

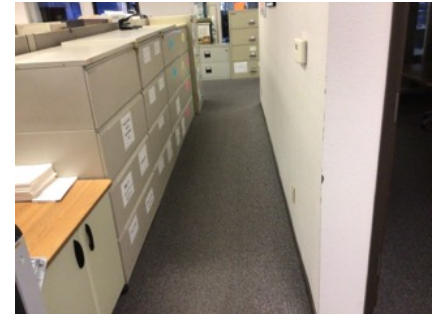
- 69 • *As-Built Description:*
Corridor less than 44" wide.
- *Original Description:*
Corridor decreases to 38" wide for a run of 14'-8".
- *As-Built:* **38" wide**
- *Proposed Solution:*
Remove or relocate furniture and storage items.

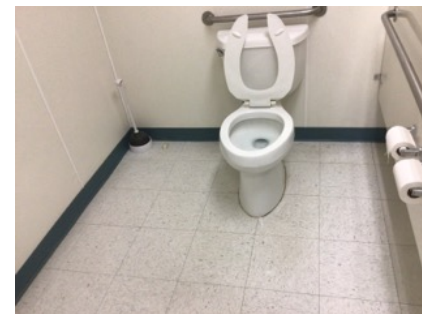
- 78 • *As-Built Description:*
Stall door to accessible compartment not self closing.
- *Original Description:*
Self-closing mechanism is not working properly and door handles are not present.
- *Proposed Solution:*
Adjust closer.

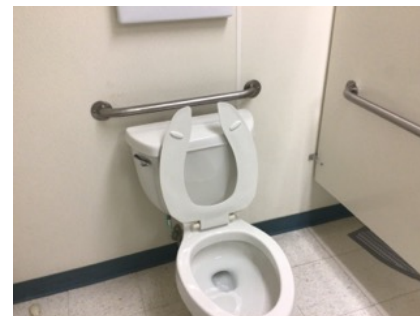
80	<ul style="list-style-type: none"> As-Built Description: Grab bars not at 33" to 36" from floor Original Description: Rear grab bar mounted at 32-5/8" above finished floor. As-Built: 32.5" high Proposed Solution: Relocate accessible grab bars. 	<p>ADAAG 91 4.16.4</p> <p>ADA 2010 609.4</p> <p>CBC 2007 1115B.4.1.3.1 & 2</p> <p>CBC 2019 11B-609.4</p>	1	JOB	\$780	\$780
		<p>Mitigated: <input type="radio"/> YES <input checked="" type="radio"/> NO</p> <p>Priority 3</p> <p>Severity 4</p>

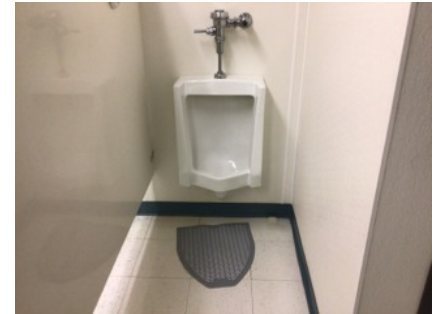
- 84 • *As-Built Description:*
Urinal flush control lever more than 48" above floor. (CA Only: 44" max.)
- *Original Description:*
Flush control at 45" above finished floor.
- *As-Built:* **45" high**
- *Proposed Solution:*
Provide accessible urinal flush control.

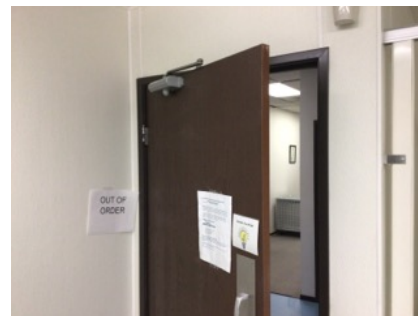
- 88
- *As-Built Description:*
At push side of door on accessible route, bottom 10" does not have a smooth, uninterrupted surface.
 - *Proposed Solution:*
Remove door stopper when altering area. Provide rubber wedge.

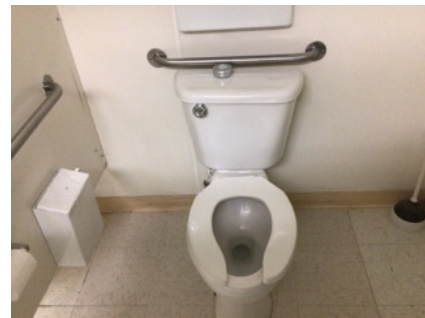
Water Closet

- 95 • *As-Built Description:*
Flush Control: Operating handle not mounted toward wide side of stall.
- *Original Description:*
Flush control is located on wall side of water closet.
- *Proposed Solution:*
Replace flush control with properly mounted accessible type, or install sensor flush.

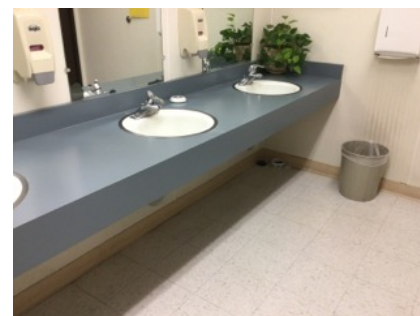
98 • *As-Built Description:*
Dispensers in sanitary facilities, such as for towels, soap, sanitary napkins, seat covers, etc., and waste receptacles more than 48" (CA only: 40") from floor to highest operating slot or control.

• *Original Description:*
Seat cover dispenser located at 43" above finished floor.

• *As-Built:* **SCD: 43" high**

• *Proposed Solution:*
Relocate existing restroom accessories.

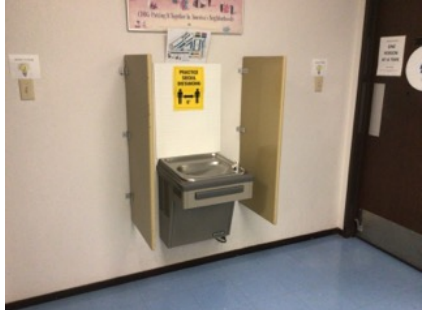
<p>101</p> <ul style="list-style-type: none"> As-Built Description: Wall- and post-mounted cantilevered units: Knee space not provided at drinking fountain (27" high, 8" deep, 30" wide from front of drinking fountain). As-Built: Knee space: 26" high Proposed Solution: Provide new, accessible fountain. 	<p>ADAAG 91 4.15.5(1) ADA 2010 602.2 CBC 2007 1115B.4.6.2 CBC 2019 11B-602.2</p>	<p>1 JOB \$9,600 \$9,600</p>
---	--	-------------------------------------
