Americans with Disabilities Act Transition Plan

Sonoma County Community Development Commission
Sonoma County Housing Authority
1440 Guerneville Road, Santa Rosa, CA 95403-4107

Facility: **Sonoma County Housing Authority**

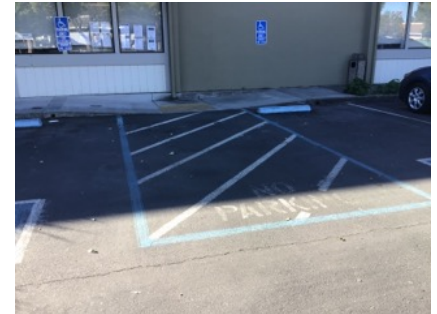
Parking

1	<ul style="list-style-type: none"> • <i>As-Built Description:</i> Accessible parking space smaller than 8' wide (CA only: 9' x 18'). • <i>Original Description:</i> Van parking stall width is 106-1/2". • <i>As-Built:</i> 106.5" wide • <i>Proposed Solution:</i> Modify parking space(s) to create accessible space. 	<p>ADAAG 91 4.6.3</p> <p>ADA 2010 502.2</p> <p>CBC 2007 1129B.3.1</p> <p>CBC 2019 11B-502.2</p>	1	JOB	\$600	\$600
	<p>Mitigated:</p> <p><input type="radio"/> YES</p> <p><input type="radio"/> NO</p>		<p>Priority 1</p> <p>Severity 4</p>

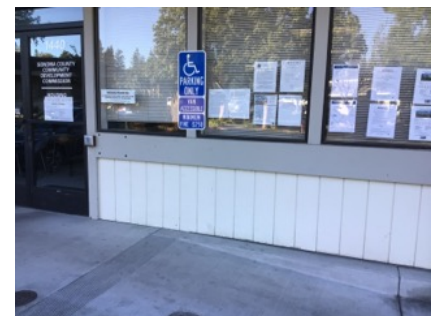
2	<ul style="list-style-type: none"> • <i>As-Built Description:</i> Parking sign is not located between 60" and 80" above the finish floor or ground surface measured to the bottom of the sign. • <i>Original Description:</i> Parking signage is too low at 43" to bottom of sign from finished floor. • <i>As-Built:</i> 43" high at bottom of sign • <i>Proposed Solution:</i> Remount existing sign at accessible height. 	<p>ADAAG 91 4.6.4</p> <p>ADA 2010 502.7</p> <p>CBC 2007 1129B.4</p> <p>CBC 2019 11B-502.6</p>	1	JOB	\$135	\$135
	<p>Mitigated:</p> <p><input type="radio"/> YES</p> <p><input type="radio"/> NO</p>		<p>Priority 1</p> <p>Severity 4</p>

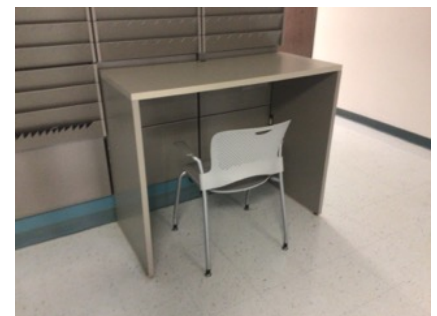
Reach Range

- 13
- *As-Built Description:*
Reach height for front approach to control or access point over an obstruction with 27" min. knee clearance and 25" max. deep exceeds 44".
 - *Original Description:*
Pamphlet display area above counter, which is 20 -3/4" deep, is out of reach range. All pamphlet access in this area is above 44".
 - *As-Built:* **Greater than 44" high over 20.75" deep to pamphlets**
 - *Proposed Solution:*
Modify equipment or mounting.

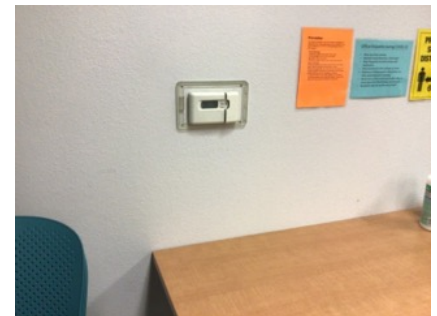
Reach Range

- 25 • *As-Built Description:*
Reach height to control or access point, exceeds 48" or is less than 15".
- *Original Description:*
Thermostat is out of reach range. Controls at 49" above finished floor.
- *As-Built:* **Greater than 49" high**
- *Proposed Solution:*
Modify equipment or mounting.

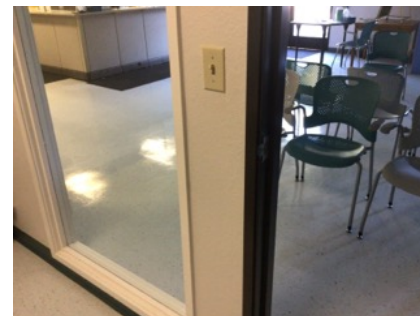
Turning Space

- 29 • *As-Built Description:*
The area does not provide a minimum 60" diameter turning space within to allow maneuvering through the space.
- *Original Description:*
Interview rooms A & B do not provide room for 60" diameter turning radius at table.
- *Proposed Solution:*
Modify area to provide sufficient maneuvering space.

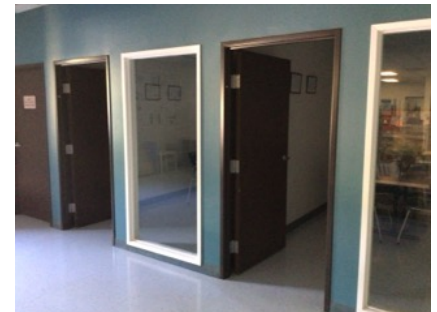
Signage

- 32 • *As-Built Description:*
Existing sign designating permanent room or space is noncompliant.
- *Original Description:*
Interview rooms A, B, C & D do not have room identification signage.
- *Proposed Solution:*
Provide compliant signage.

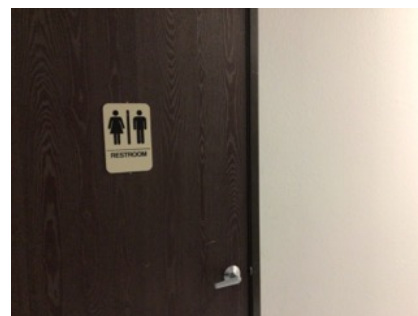
Signage

37	<ul style="list-style-type: none"> • <i>As-Built Description:</i> Entrance to toilet or bathing facility not identified with ADAAG compliant signage. • <i>Original Description:</i> Incorrect signage installed. • <i>Proposed Solution:</i> Provide ADA compliant sign mounted at 48" min. above to baseline of the lowest Braille cells and 60" max. to baseline of the highest line of raised characters on nearest adjacent wall, on latch side of a single door (located not to cause a Braille reader to stand within the door swing). 	ADAAG 91 4.1.3(16)(a)	1	JOB	\$270	\$270
		ADA 2010 216.8				
		CBC 2019 11B-216.8				
		Mitigated: <input type="radio"/> YES <input type="radio"/> NO

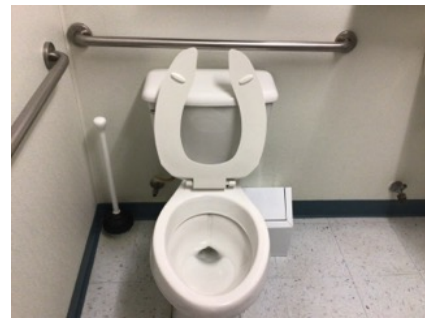
Water Closet

- 42 • *As-Built Description:*
Flush Control: Operating handle not mounted toward wide side of stall.
- *Original Description:*
Flush control is located on wall side of water closet.
- *Proposed Solution:*
Replace flush control with properly mounted accessible type, or install sensor flush.

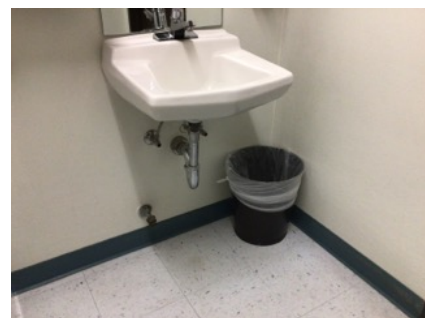
Lavatory

- 43 • *As-Built Description:*
Hot or sharp-surfaced water/drain pipe not insulated or covered.
- *Original Description:*
Pipes under lavatory are not insulated.
- *Proposed Solution:*
Insulate or cover water/drain pipe.

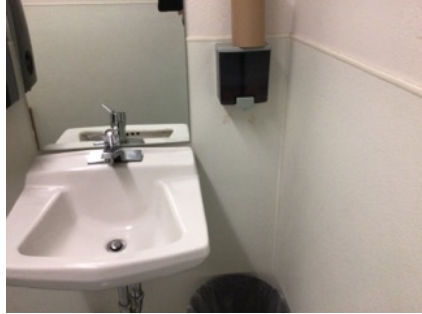
Item no., Rm no. and Name	Existing Architectural Barrier and Proposed Solution	Codes / Mitigation Info	Qty	Unit	Cost	Total
Accessories						
44	<ul style="list-style-type: none"> <i>As-Built Description:</i> Dispensers in sanitary facilities, such as for towels, soap, sanitary napkins, seat covers, etc., and waste receptacles more than 48" (CA only: 40") from floor to highest operating slot or control. <i>Original Description:</i> Soap dispenser operable part mounted at 41" above finished floor. <i>As-Built:</i> SD: 41" high <i>Proposed Solution:</i> Relocate existing restroom accessories. 	ADAAG 91 4.23.7 ADA 2010 308.2.1 CBC 2007 1115B.8.3 CBC 2019 11B-603.5	1	JOB	\$300	\$300
		Mitigated: <input type="radio"/> YES <input type="radio"/> NO Priority 2 Severity 4

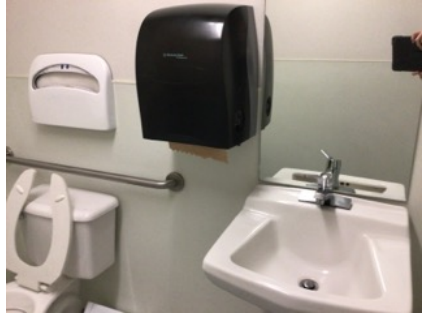
45	<ul style="list-style-type: none"> <i>As-Built Description:</i> Dispensers in sanitary facilities, such as for towels, soap, sanitary napkins, seat covers, etc., and waste receptacles more than 48" (CA only: 40") from floor to highest operating slot or control. <i>Original Description:</i> Paper towel dispenser operable part mounted at 45" above finished floor. <i>As-Built:</i> PTD: 45" high <i>Proposed Solution:</i> Relocate existing restroom accessories. 	ADAAG 91 4.23.7 ADA 2010 308.2.1 CBC 2007 1115B.8.3 CBC 2019 11B-603.5	1	JOB	\$300	\$300

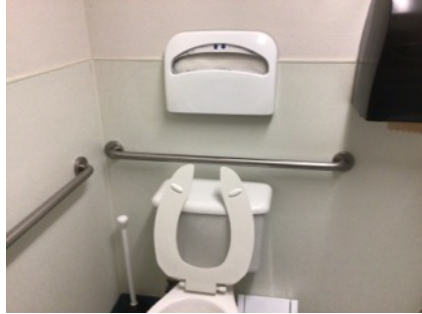
46	<ul style="list-style-type: none"> <i>As-Built Description:</i> Dispensers in sanitary facilities, such as for towels, soap, sanitary napkins, seat covers, etc., and waste receptacles more than 48" (CA only: 40") from floor to highest operating slot or control. <i>Original Description:</i> Seat cover dispenser located at 48" above finished floor. <i>As-Built:</i> SCD: 48" high <i>Proposed Solution:</i> Relocate existing restroom accessories. 	ADAAG 91 4.23.7 ADA 2010 308.2.1 CBC 2007 1115B.8.3 CBC 2019 11B-603.5	1	JOB	\$300	\$300
		Mitigated: <input type="radio"/> YES <input type="radio"/> NO Priority 2 Severity 2

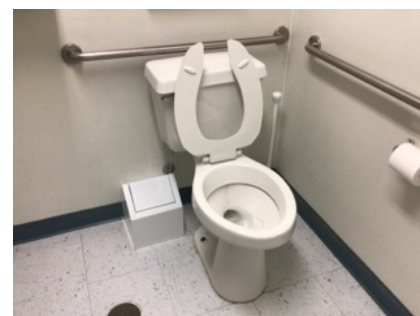
Water Closet

- 53 • *As-Built Description:*
Water closet not 16"-18" (CA: 17"-18") from near side wall to center line of water closet (2010 ADAAG: 16"-18").
- *Original Description:*
Centerline of water closet is 19" from side wall.
- *As-Built:* **19" o.c.**
- *Proposed Solution:*
Relocate existing water closet and plumbing, remount with offset closet flange to provide 18" max. from side wall.

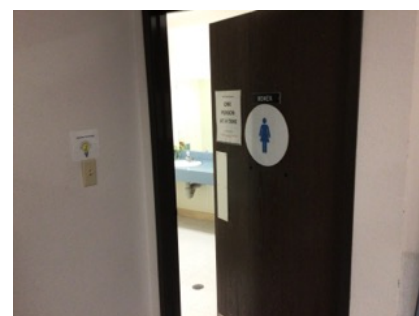
Signage

- *As-Built Description:*
Entrance to toilet or bathing facility not identified with ADAAG compliant signage.
- *Original Description:*
Incorrect signage installed.
- *Proposed Solution:*
Provide ADA compliant sign mounted at 48" min. above to baseline of the lowest Braille cells and 60" max. to baseline of the highest line of raised characters on nearest adjacent wall, on latch side of a single door (located not to cause a Braille reader to stand within the door swing).
